# MONUMENT RECORD

Corner ID: **BeBI\_I23**

## Quarter Corner

Sections 32 & 33- T10N-R02W, 2nd P.M.  
Bean Blossom Township, Monroe County, Indiana

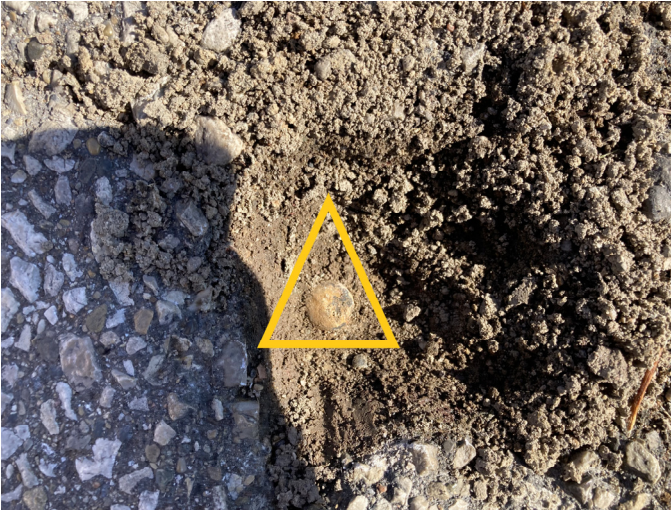
Photo Orientation & Description: BeBI\_I23 from above

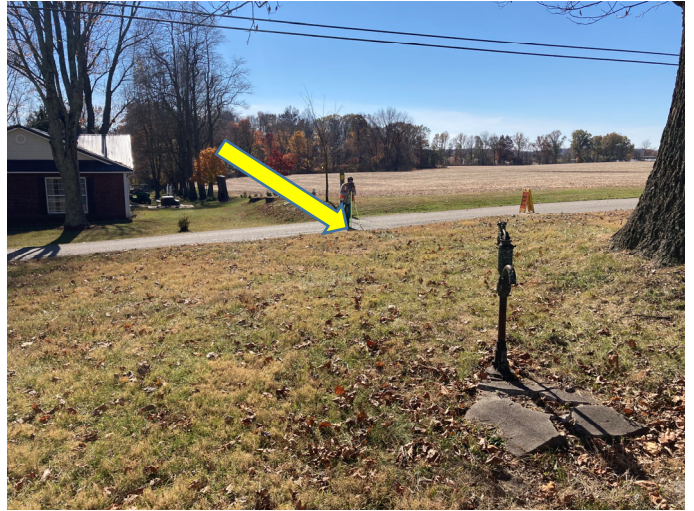
Photo Orientation & Description: Looking southwest at BeBI\_I23
